Subject: Department of Natural Resources Washington Geological Survey,
School Seismic Safety Assessment Project, Contract No. AE 410 -
Seismic Evaluation for **Royal School District**

School Buildings Evaluated in the Royal School District

1. Red Rock Elementary School, Main Building
2. Royal High School, A Gymnasium
3. Royal High School, B Main Building
4. Royal Middle School, Main Building

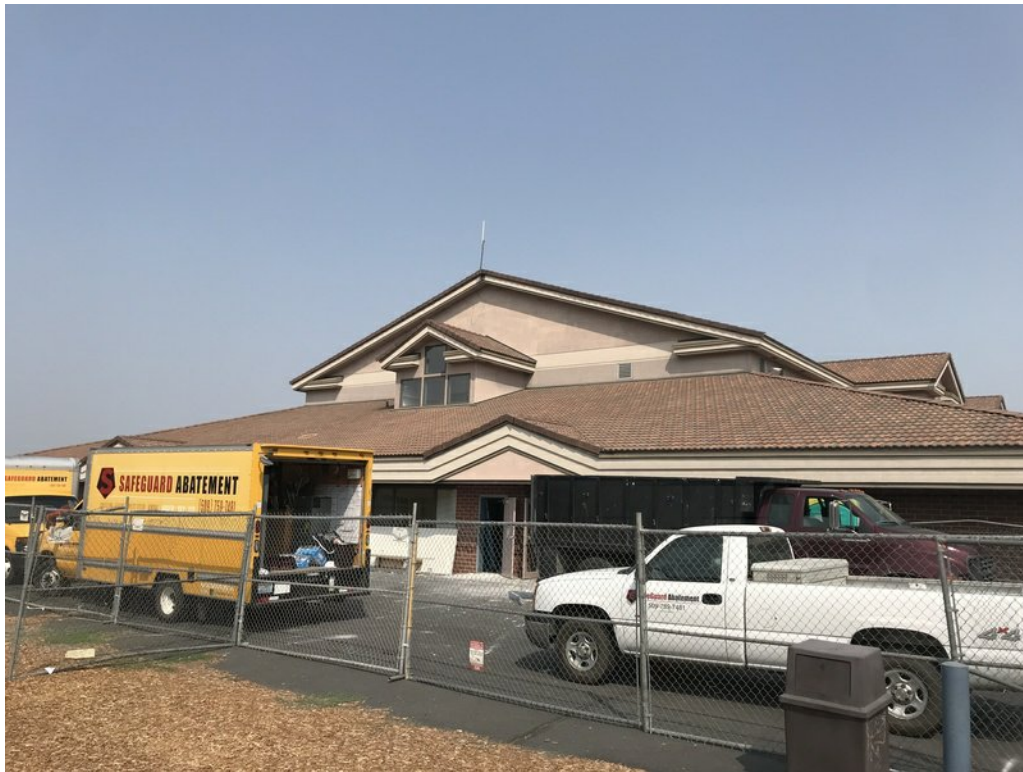
Figure 1-1. Exterior view of the south entrance.

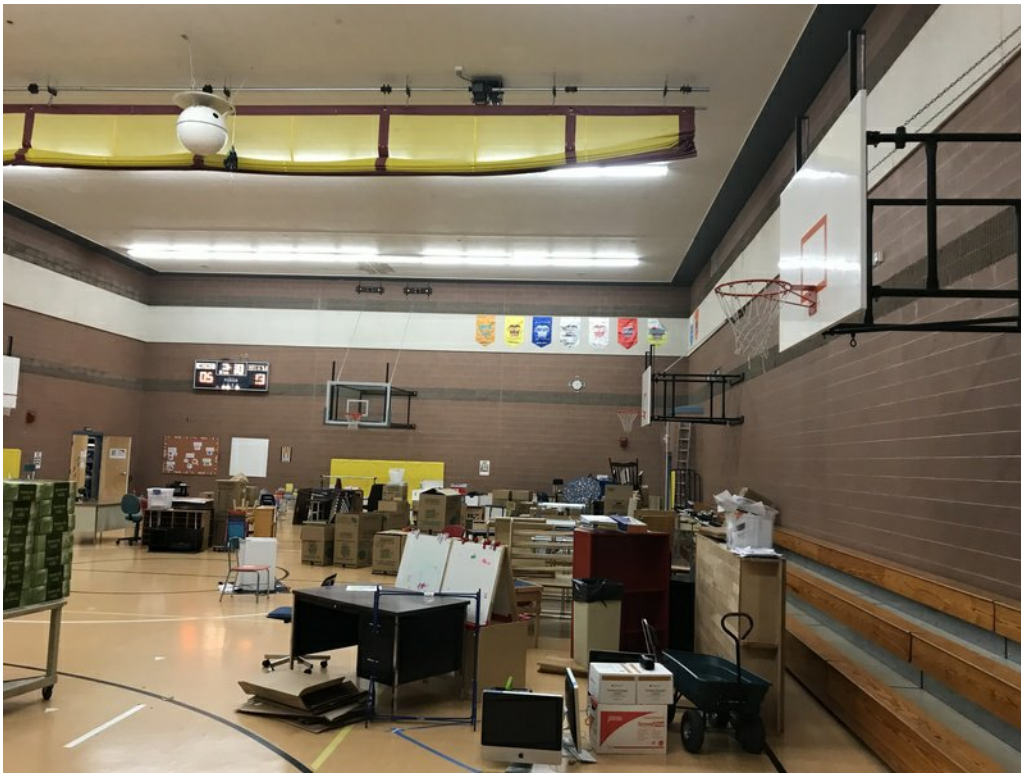
Figure 1-3. Gymnasium with CMU walls.

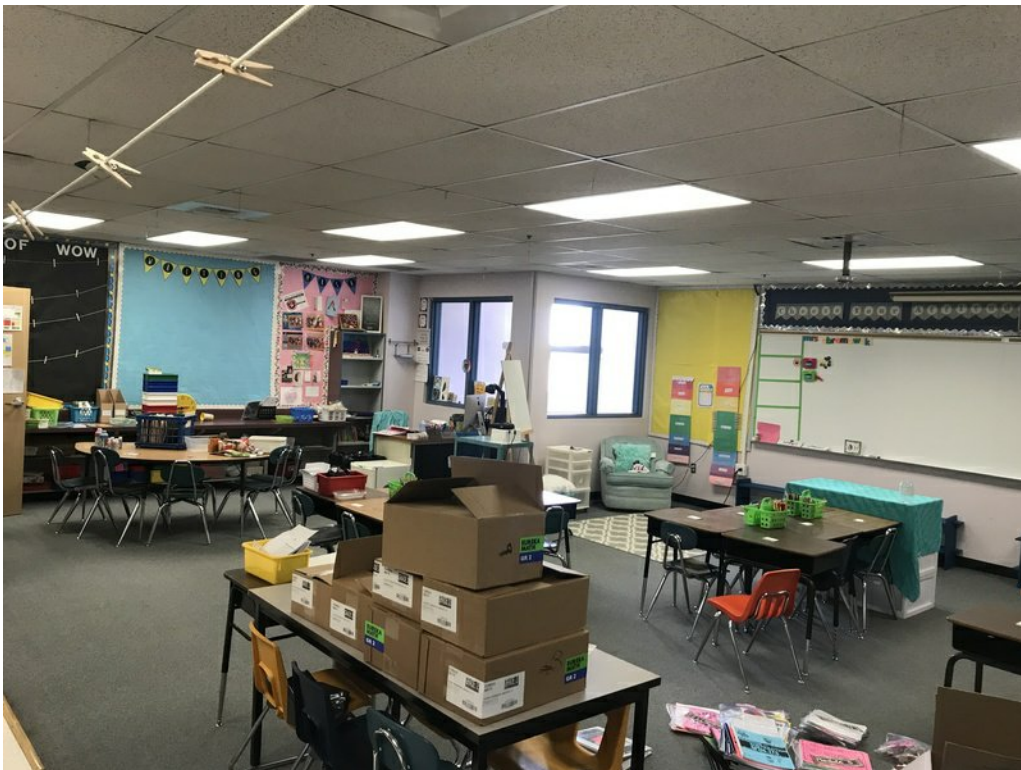
Figure 1-4. Typical classroom.

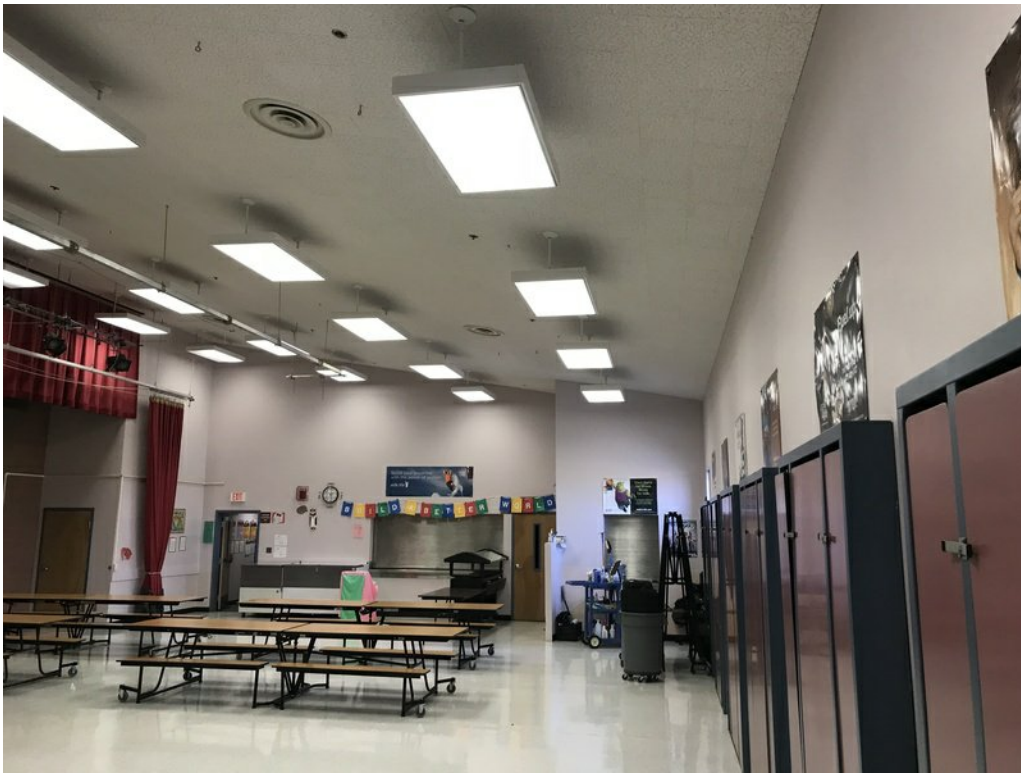
Figure 1-5. Cafeteria/multipurpose room with folding tables stored against wall.

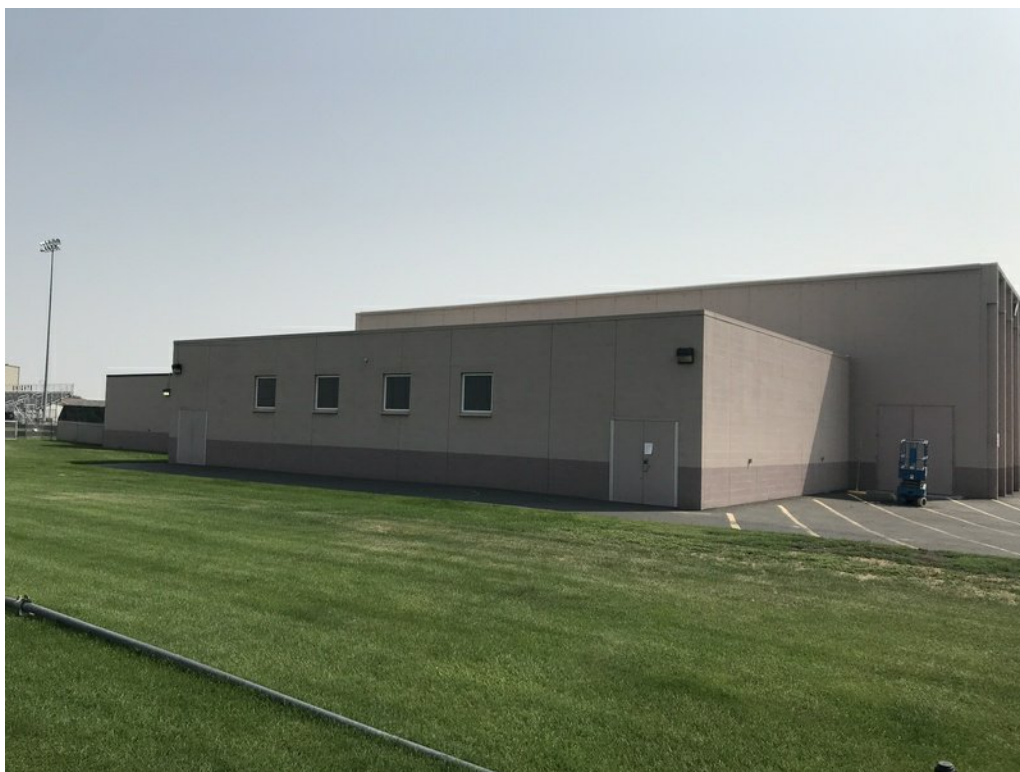
Figure 1-1. North end of building.

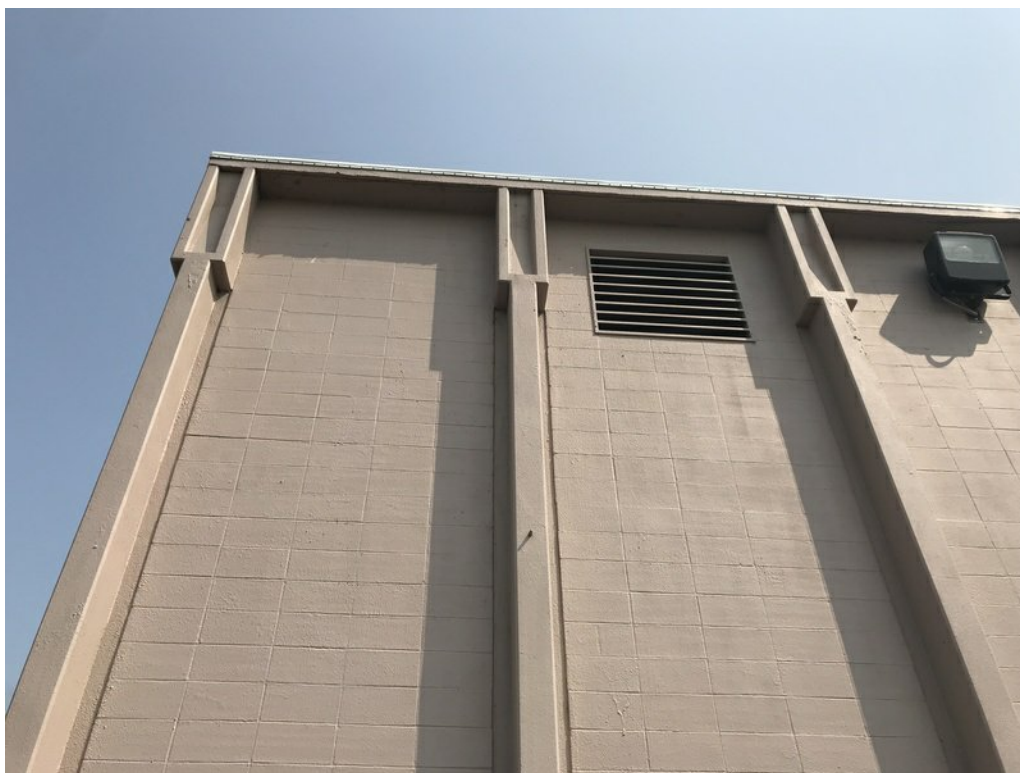
Figure 1-2. West side of the gymnasium with concrete columns, CMU infill walls, and a large vent.

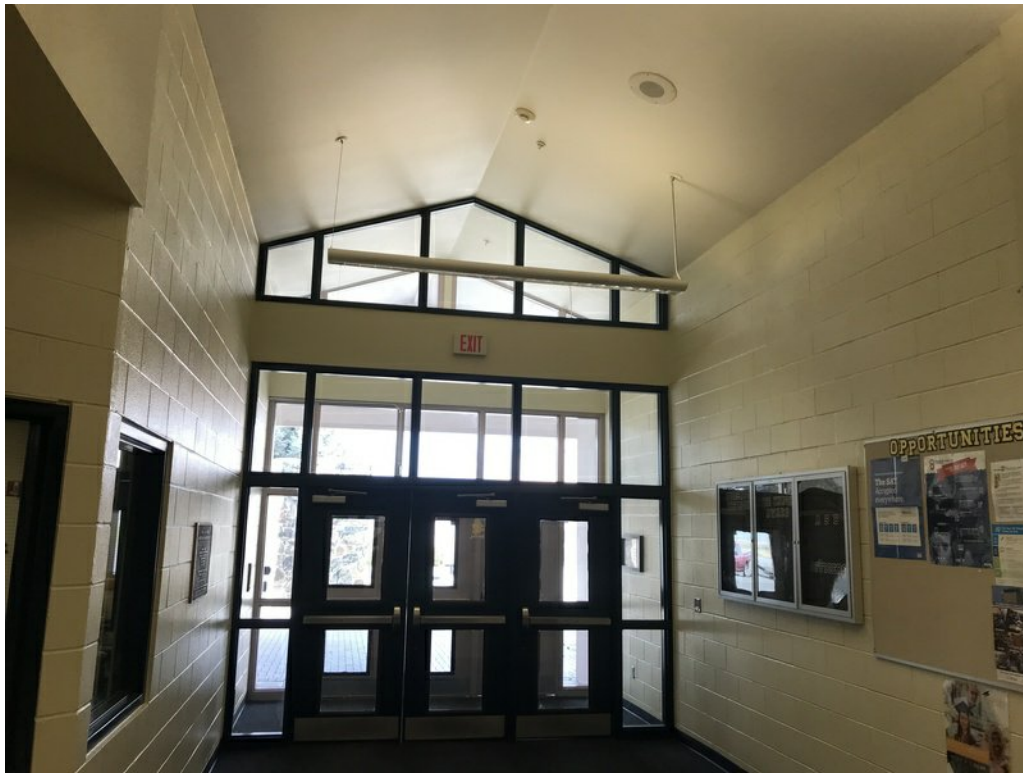
Figure 1-3. Main entrance.

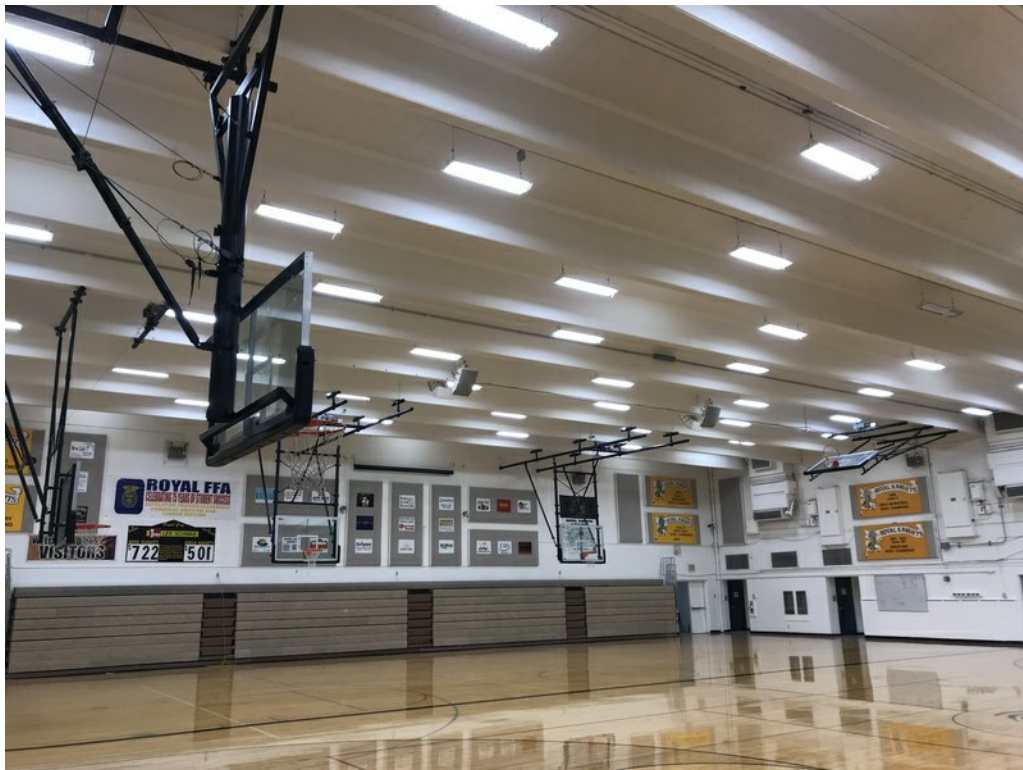
Figure 1-4. Gymnasium with visible t-beams

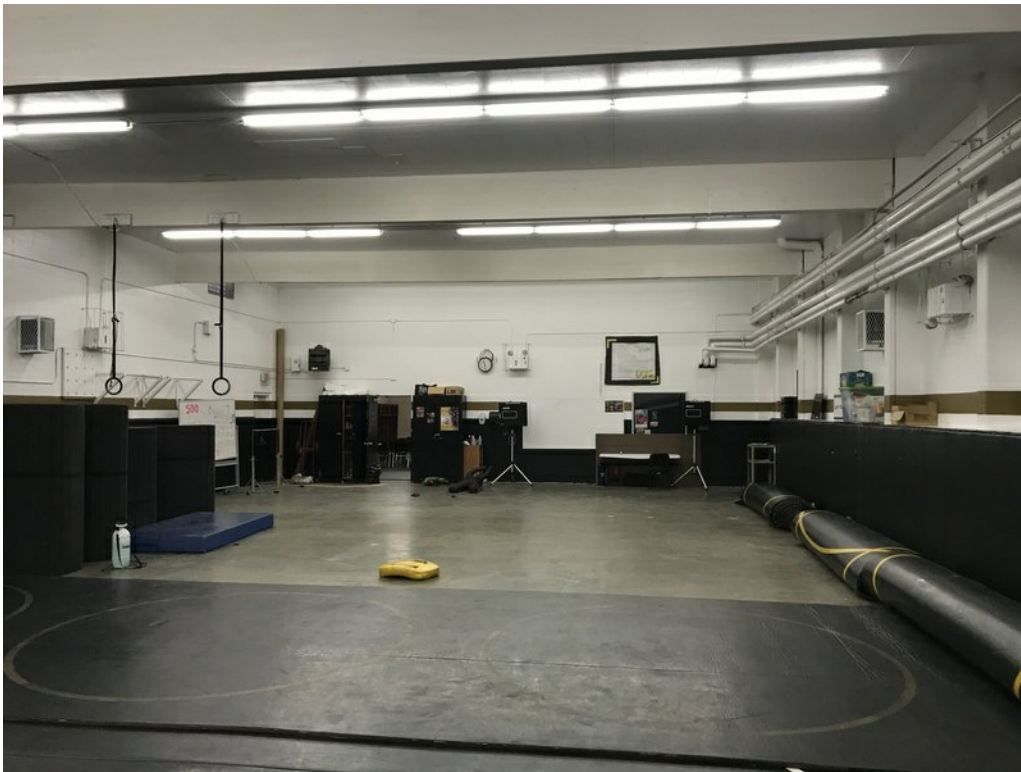
Figure 1-5. Wrestling room.

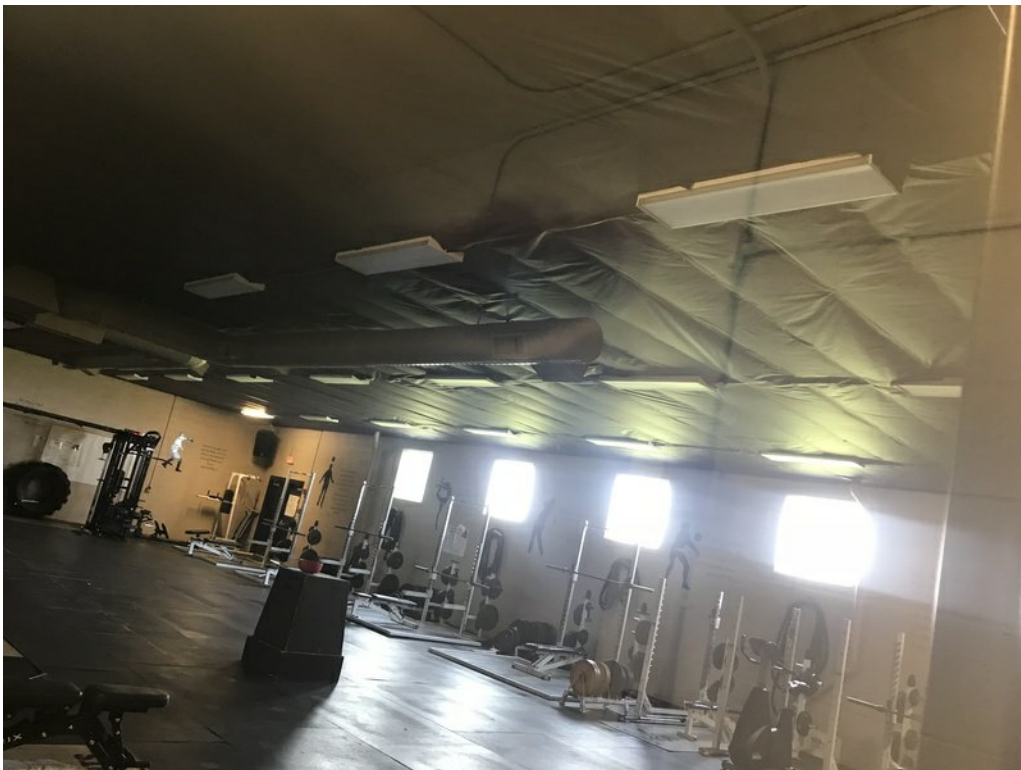
Figure 1-8. Weight room.

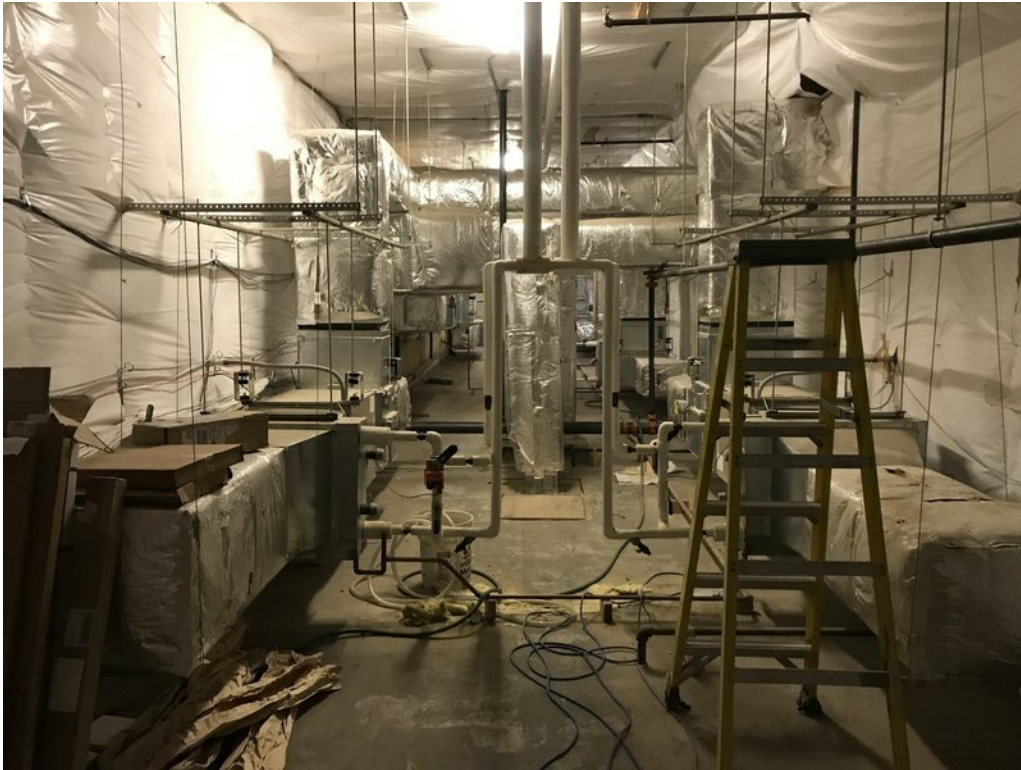
Figure 1-1. Mechanical room with ducting and pipework visible.

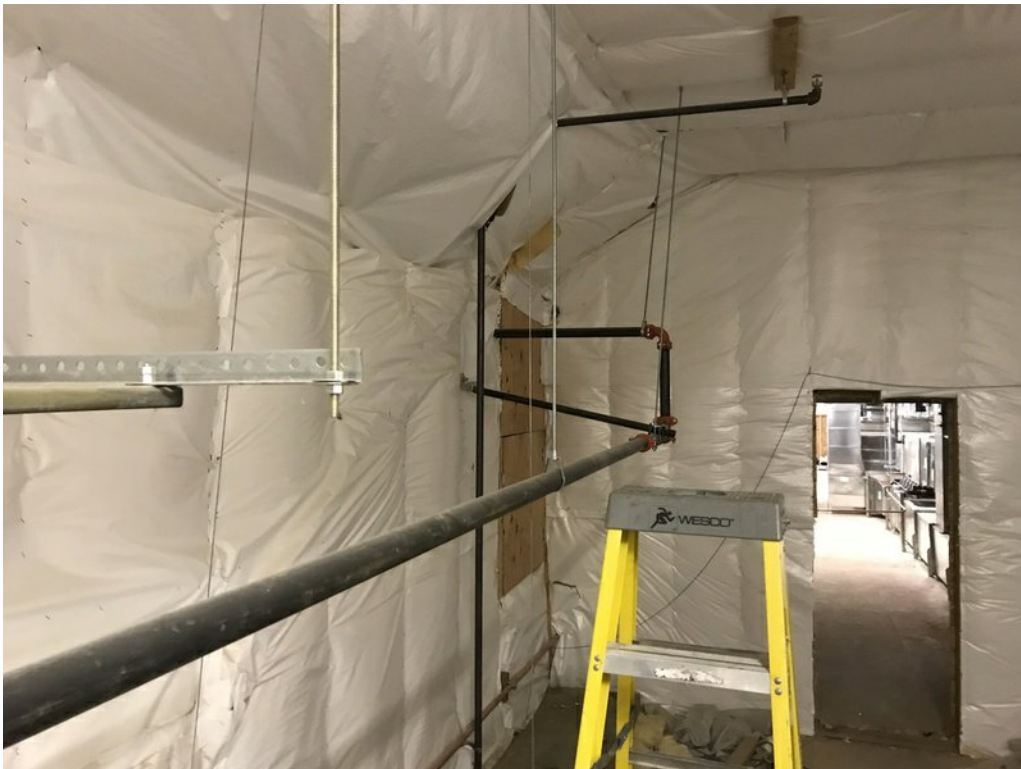
Figure 1-2. Fire line at wall.

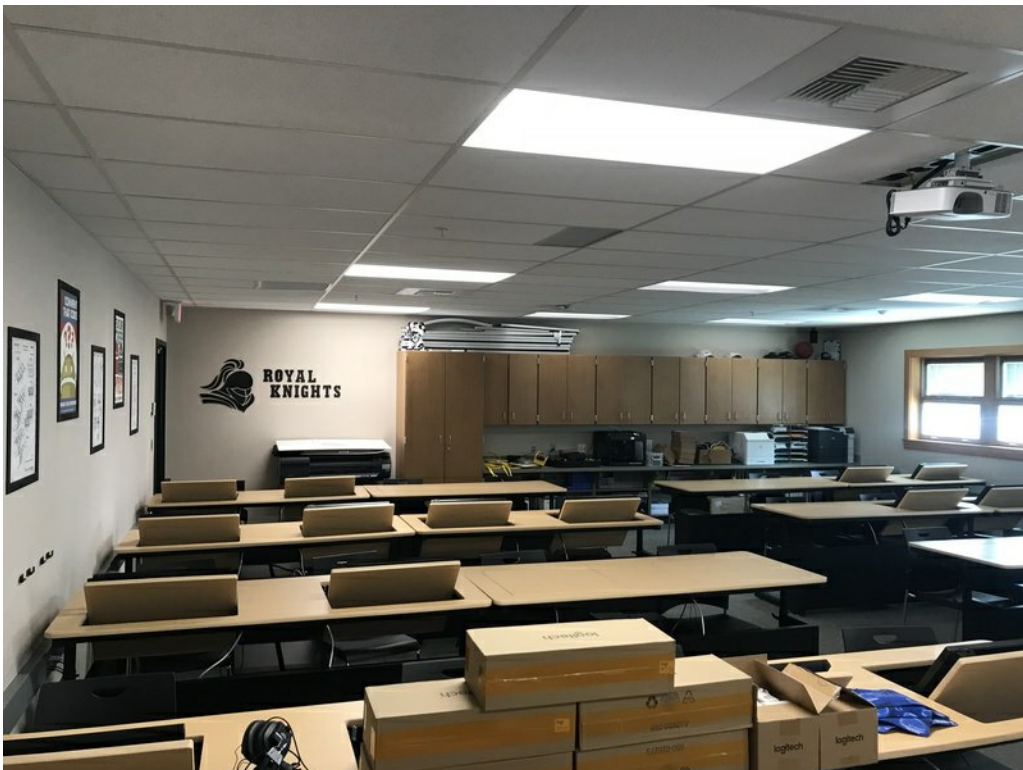
Figure 1-4. Computer lab.

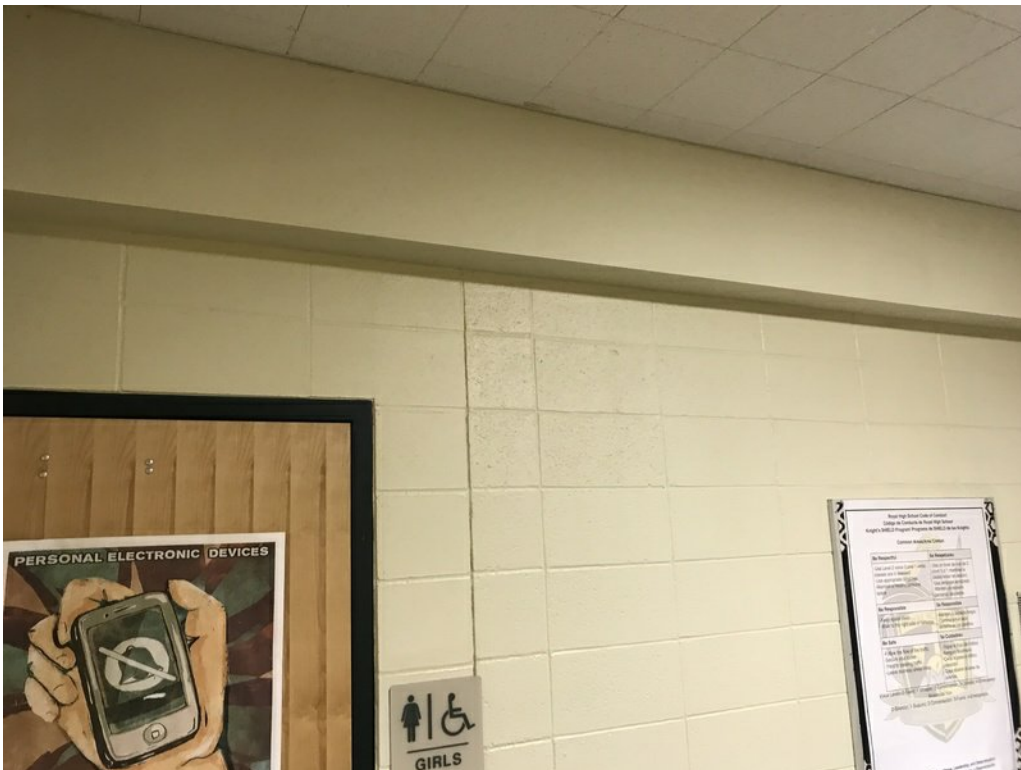
Figure 1-6. CMU corridor wall at construction joint.

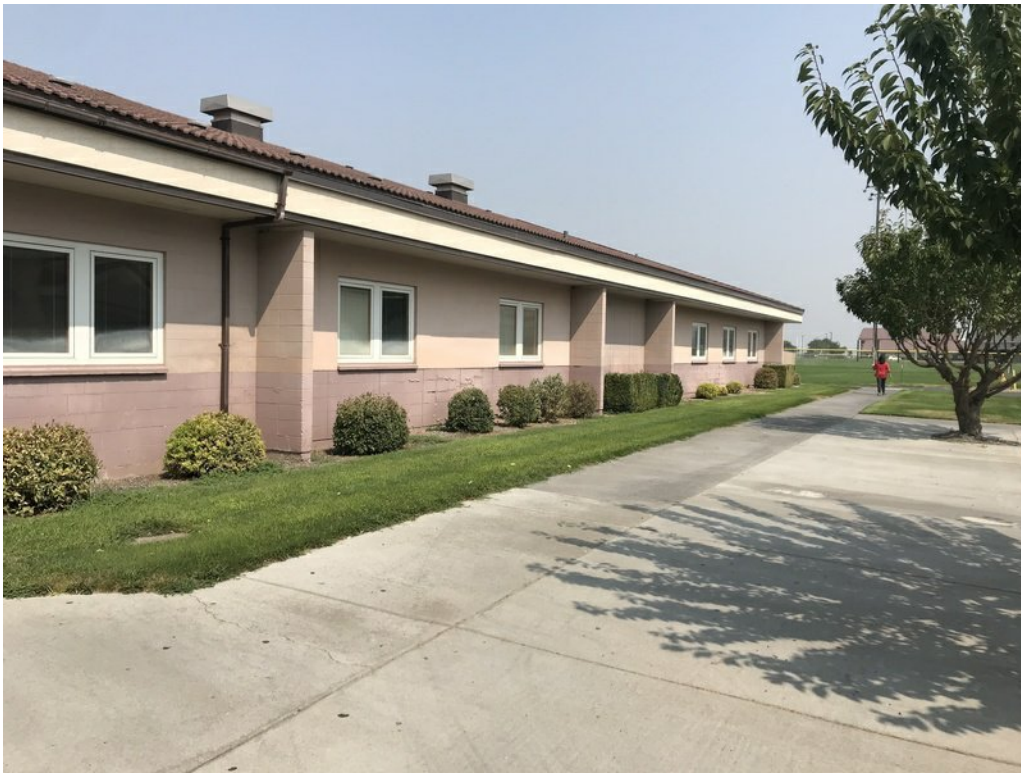
Figure 1-7. Southwest exterior wall.

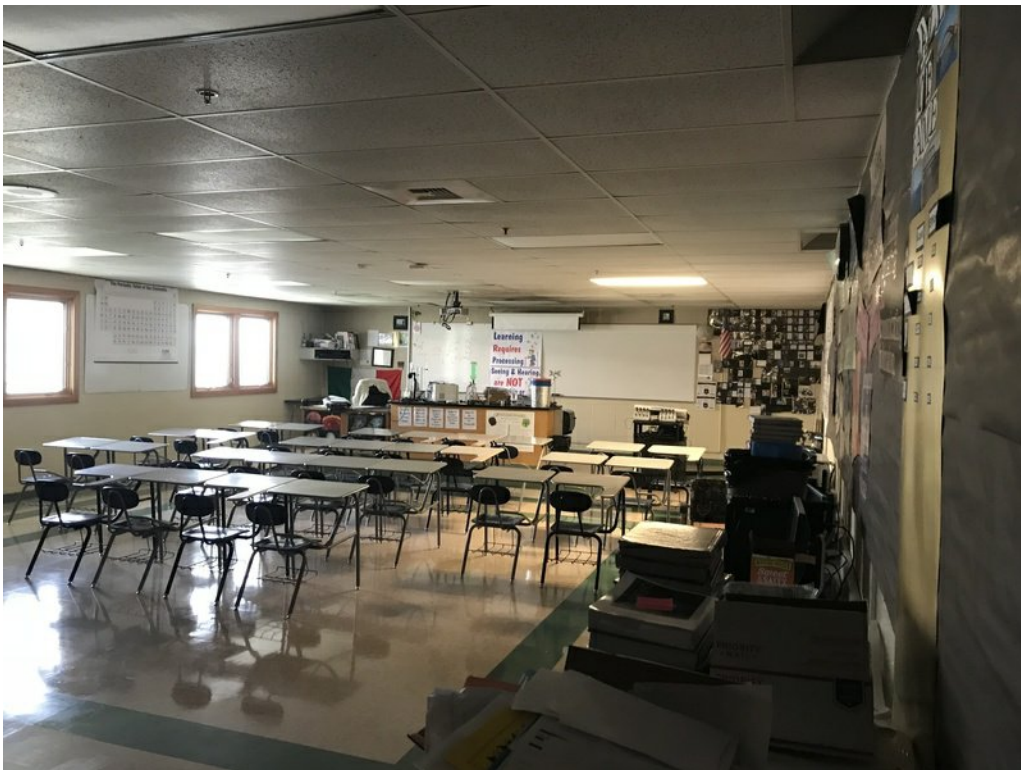
Figure 1-8. Typical classroom.

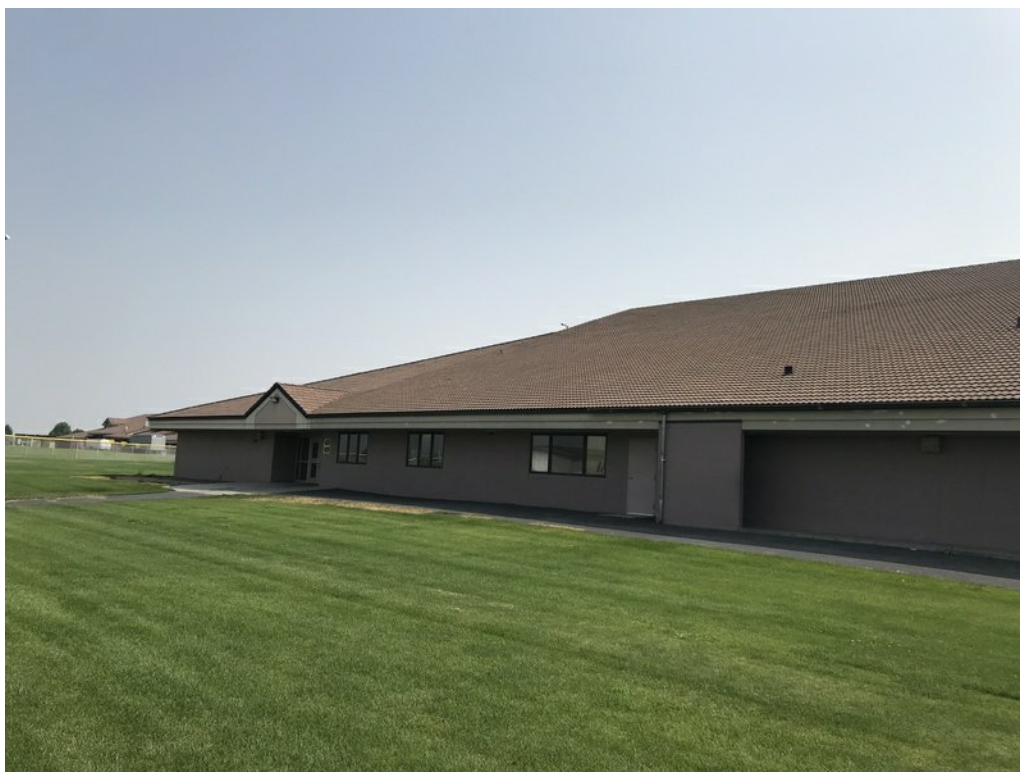
Figure 1-1. North exterior wall.

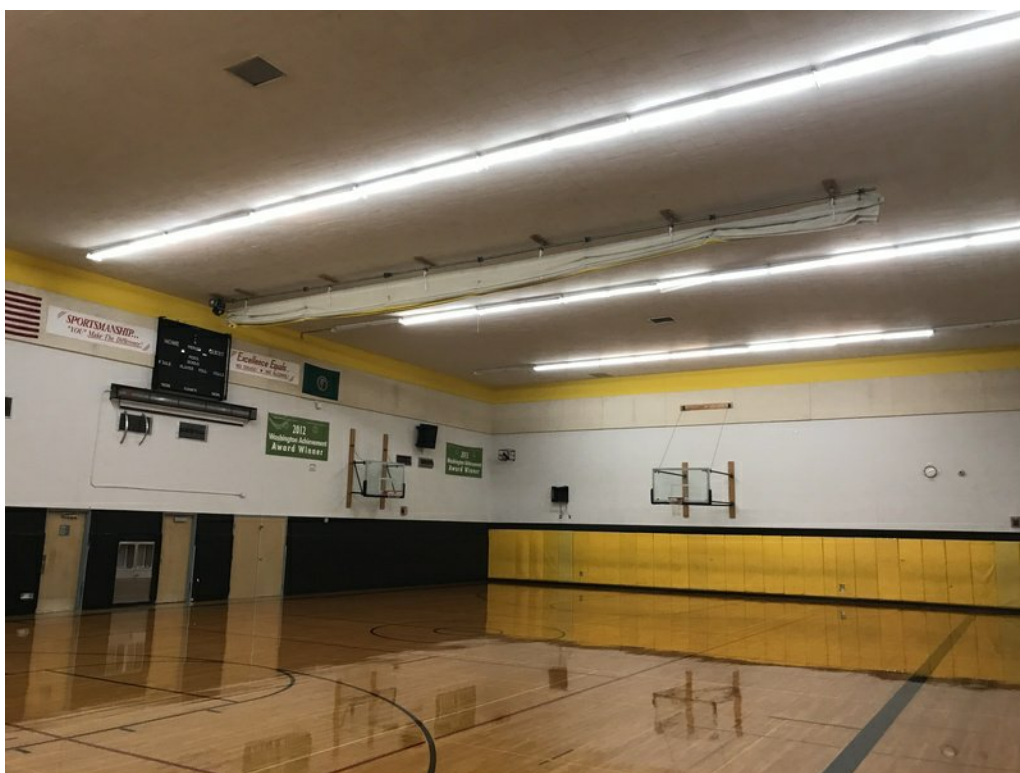
Figure 1-2. Gymnasium.

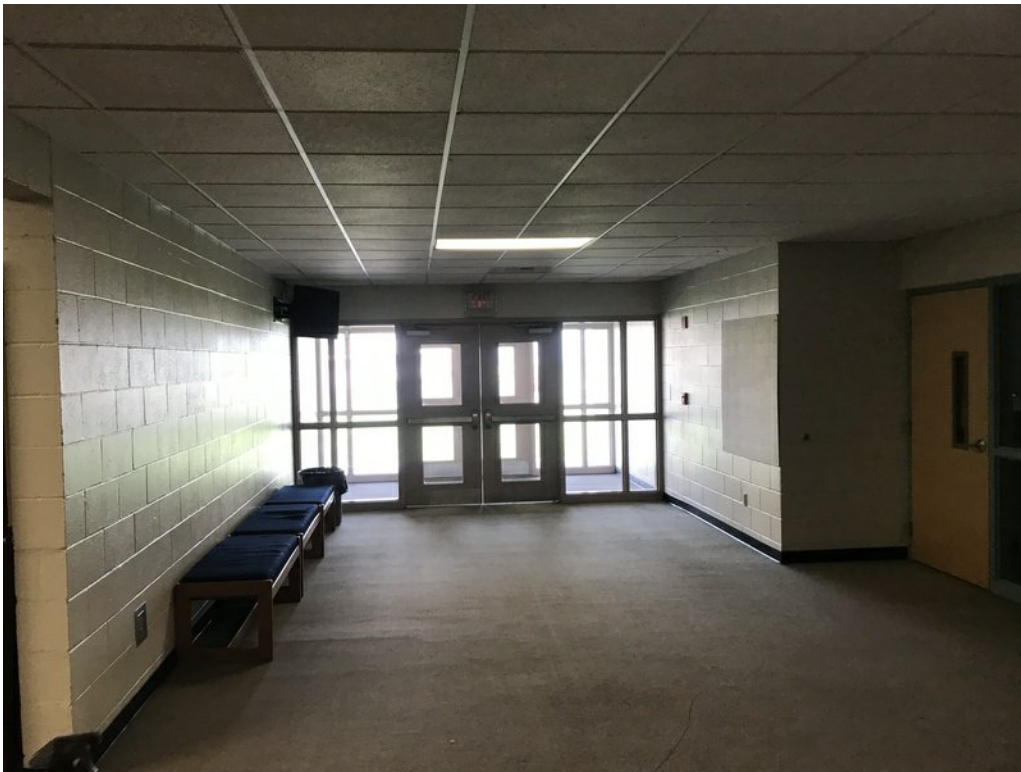
Figure 1-3. Main school entrance.

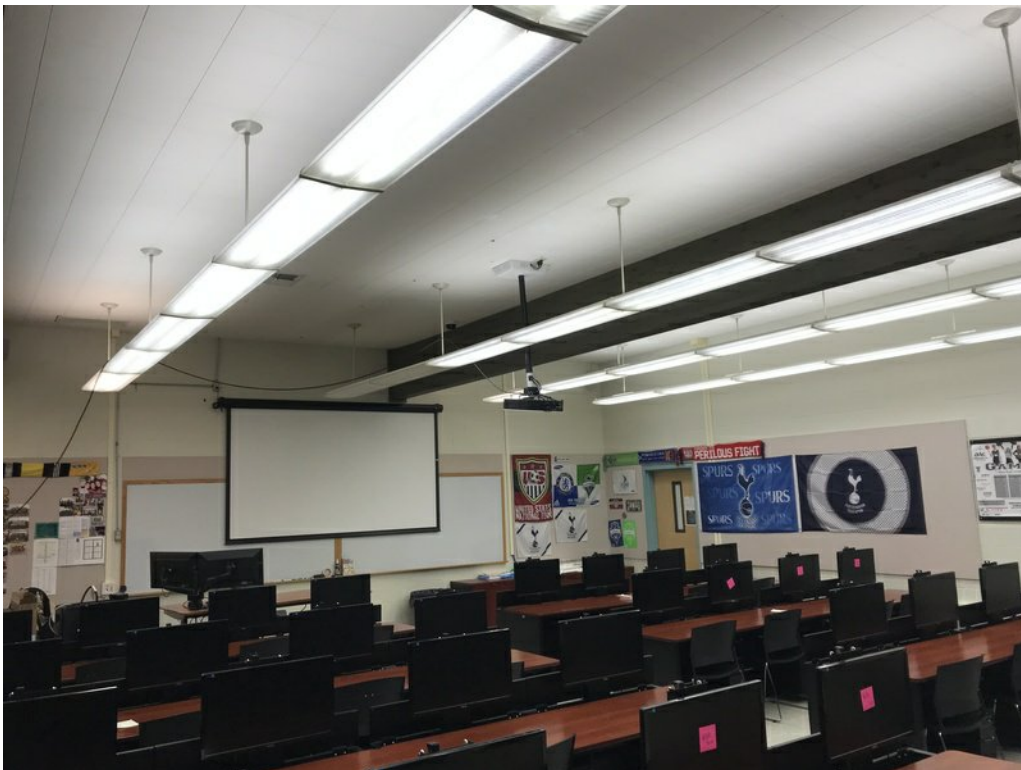
Figure 1-4. Computer lab with pendant lighting. The beam visible is a glulam beam-girder.

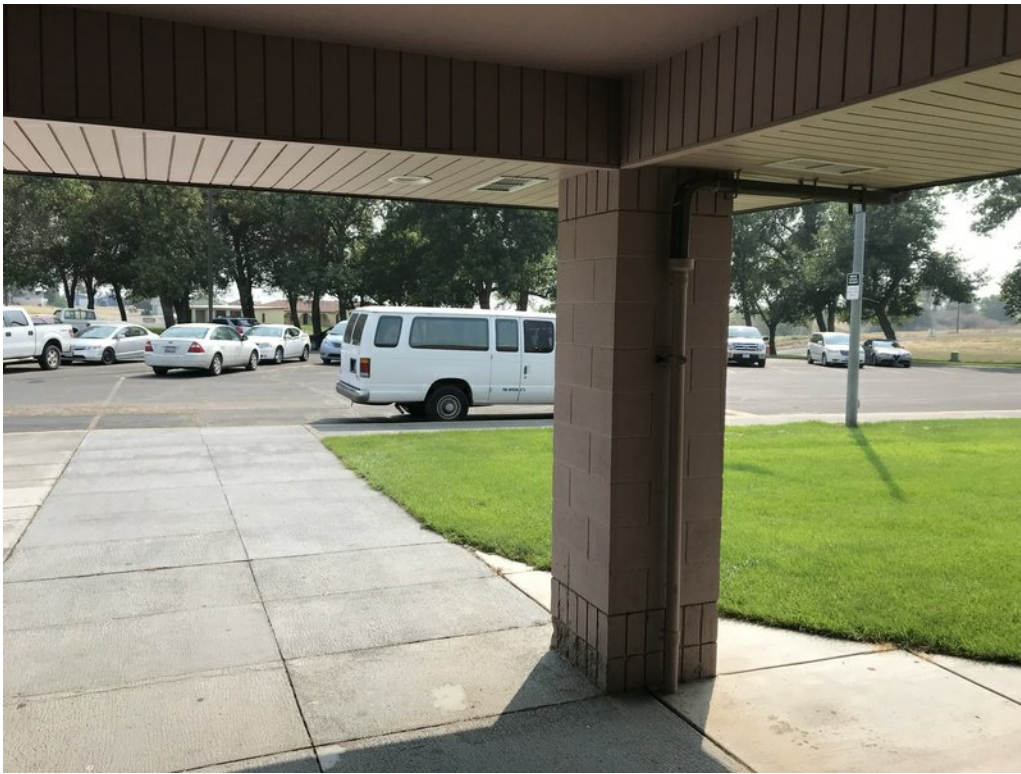
Figure 1-7. View of exterior column at main entrance.

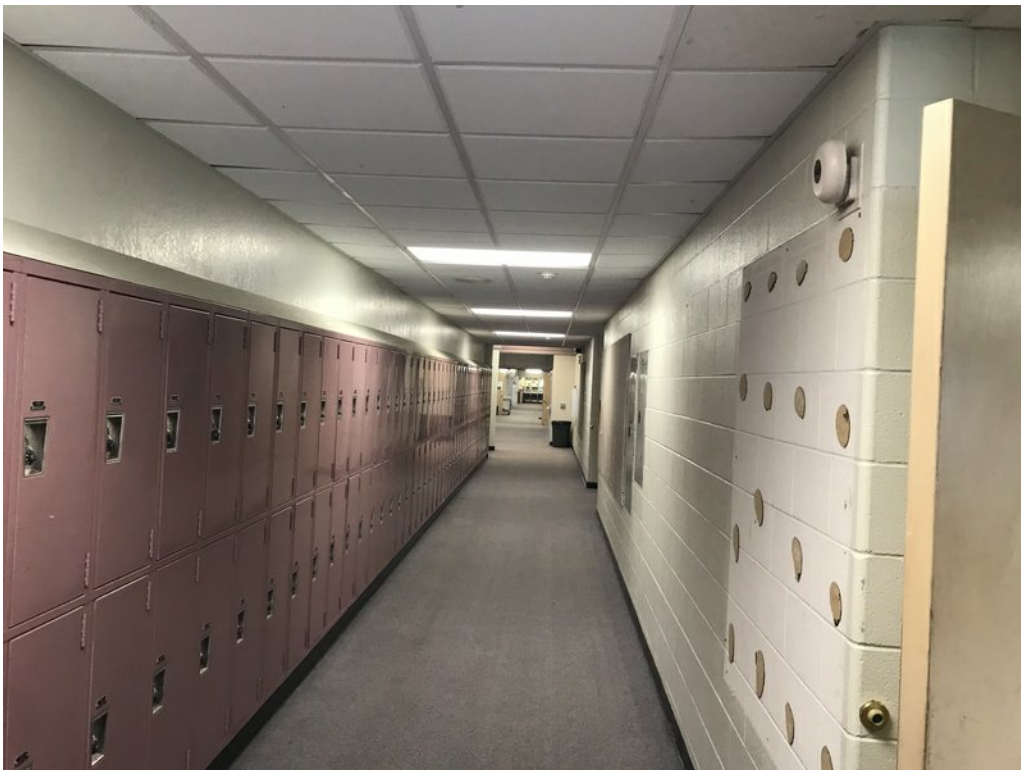
Figure 1-8. Corridor with lockers.
